DEPARTMENT OF TRANSPORTATION

Contract #: 04-0120F4Cty: SF/ALA Rte: 80 PM: 13.2/13.9File #: 69.28**WELDING INSPECTION REPORT****Resident Engineer:**Siegenthaler, Peter**Address:** 333 Burma Road**City:** Oakland, CA 94607**Report No:** WIR-024176**Date Inspected:** 29-May-2011**Project Name:** SAS Superstructure**OSM Arrival Time:** 700**Prime Contractor:** American Bridge/Fluor Enterprises, a JV**OSM Departure Time:** 1900**Contractor:** Zhenhua Port Machinery Company, Ltd (ZPMC), Changxing Island **Location:** Shanghai, China**CWI Name:** Zhu Zhong Hai**CWI Present:** Yes No**Inspected CWI report:** Yes No N/A**Rod Oven in Use:** Yes No N/A**Electrode to specification:** Yes No N/A**Weld Procedures Followed:** Yes No N/A**Qualified Welders:** Yes No N/A**Verified Joint Fit-up:** Yes No N/A**Approved Drawings:** Yes No N/A**Approved WPS:** Yes No N/A**Delayed / Cancelled:** Yes No N/A**Bridge No:** 34-0006**Component:** Orthotropic Box Girder(OBG)**Summary of Items Observed:**

OBG TRIAL ASSEMBLY YARD

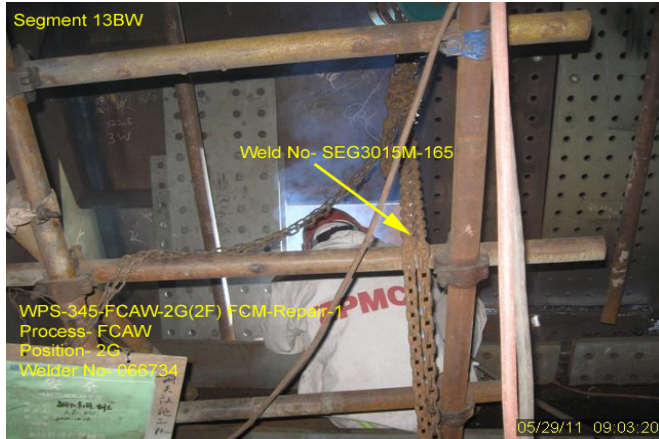
This QA Inspector observed ZPMC qualified welding personnel identified as 066734 perform Flux Cored Arc Welding (FCAW), weld joint identified as SEG3015M-165 ; located On Orthotropic Box Girder (OBG) Bottom Plate to Longitudinal Diaphragm CJP Weld; ZPMC Quality Control (QC) is identified as Mr. Sun Tian Liang. This QA Inspector observed the base material appears to have been preheated by an electrical heating element prior to welding. The Welding Repair Report (WRR) was B-WR2110.ZPMC Quality Control (QC) Mr. Sun Tian Liang was onsite monitoring the welding variables. The welding variables recorded by QC appeared to comply with applicable WPS-345-FCAW-2G (2F) ESAB-Repair. See attached photo for further details.

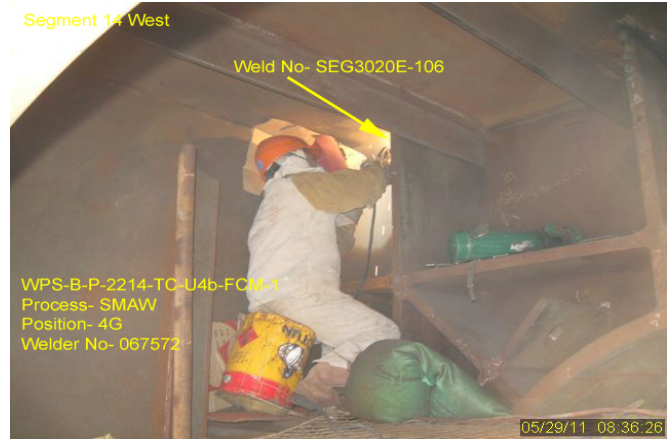
This QA Inspector observed ZPMC qualified welding personnel identified as 067572 perform Shielded Metal Arc Welding (SMAW), weld joint identified as SEG3020E-106 ; located On Orthotropic Box Girder (OBG) Floor Beam I-Rib to SA3416A CJP Weld; ZPMC Quality Control (QC) is identified as Mr. Zhu Lin. This QA Inspector observed the base material appears to have been preheated by an electrical heating element prior to welding. ZPMC Quality Control (QC) Mr. Zhu Lin was onsite monitoring the welding variables. The welding variables recorded by QC appeared to comply with applicable WPS-B-P-2214-TC-U4b-FCM-1. See attached photo for further details.
